Technical Newsletter

No:  
36

Subject:  
Defect suction cover 132 423 for Maxi N

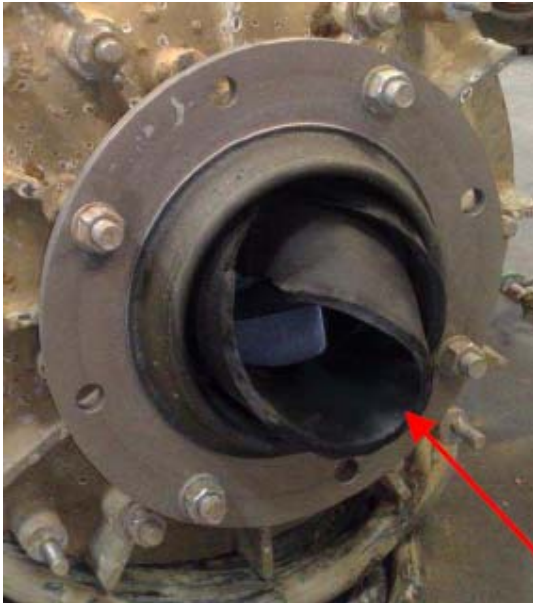
During 2010/2011 there has been reports of poor bonding between rubber and metal on the suction cover 132 423, resulting in the rubber coming loose during operation. See picture below.

Since November 2010 the manufacturing problem has been solved. Defect components in local stock are detected by testing the bonding with pliers. If the bonding is defect the rubber will easily come off.

Please check your stock to prevent further pump failures, claim defect components according to standard procedure.
